Technical Area: Mechanical Systems  
**Repair of Helicopter Gears-Phase II**

Suren Rao, Doug McPherson  
Applied Research Laboratory  
The Pennsylvania State University  
and  
Gary Sroka  
REM Chemicals

**Abstract**

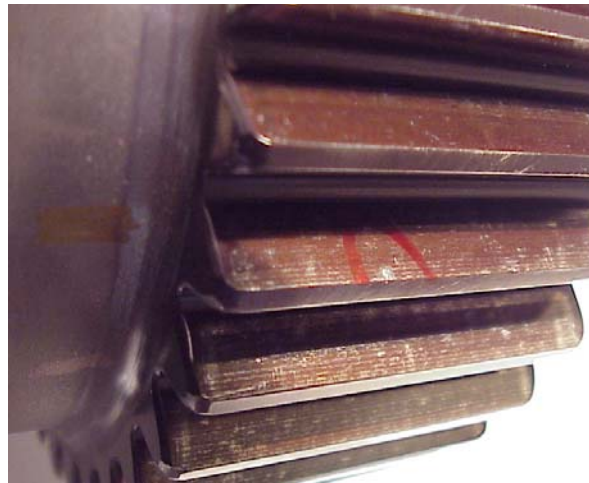
**Figure 2: Typical FOD on Gear**

Costs for replacement gears are high. In the Mix box, the cost of the individual gears range from \$6000, for the cheapest gear, to almost \$30,000 for the most expensive gear. Typical gear tooth damage encountered are FOD and gray staining. A typical FOD on a gear is illustrated in Figure 2.

A cross section profile of a FOD on a scrapped gear is illustrated in Figure 3. Eliminating the slope it can be observed that the actual depth of the damage is about 0.00006 inch. Consequently, any process that can remove this damaged area, while maintaining gear tooth geometry, could be used to salvage this gear. After evaluating a number of processes that are traditionally used for surface enhancement, the Isotropic Super Finishing (ISF) process<sup>(1, 2, 3, 4)</sup> developed by REM Chemical of Brenham, Texas was selected for this purpose.

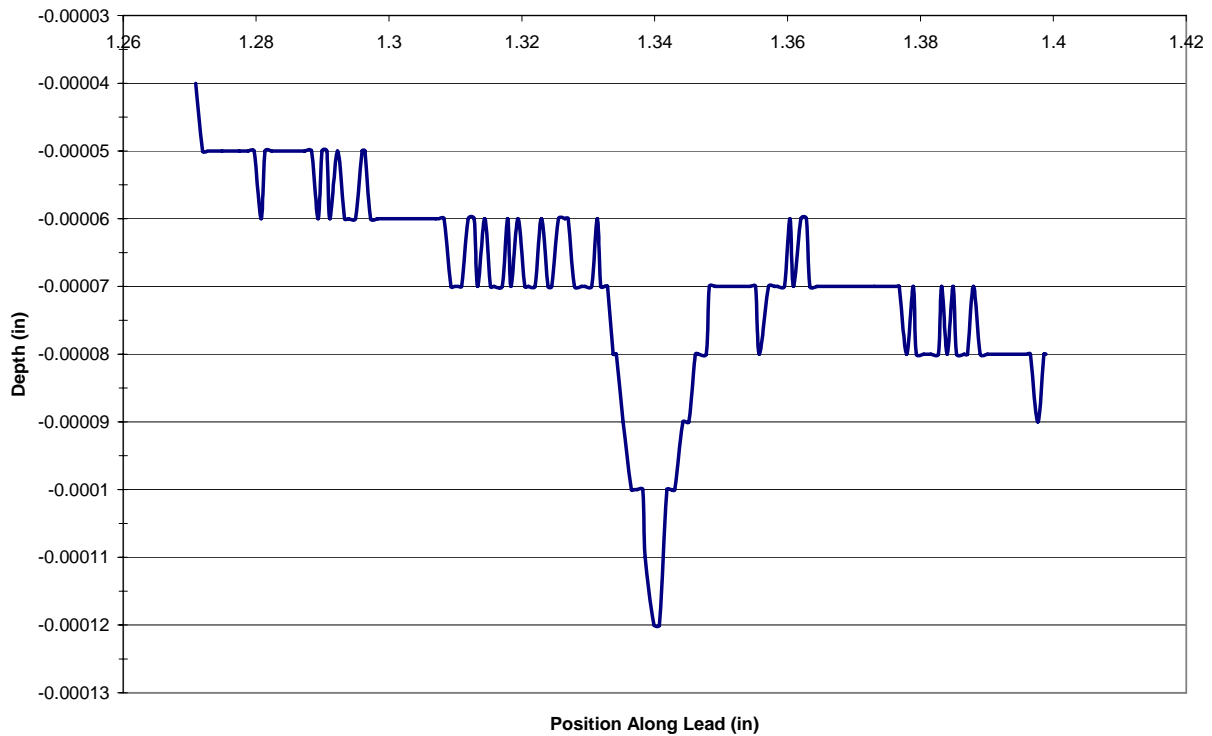
**Figure 3: Typical Profile of Gear Tooth FOD**

**Zeiss Trace of FOD on CH-46 Pinion**

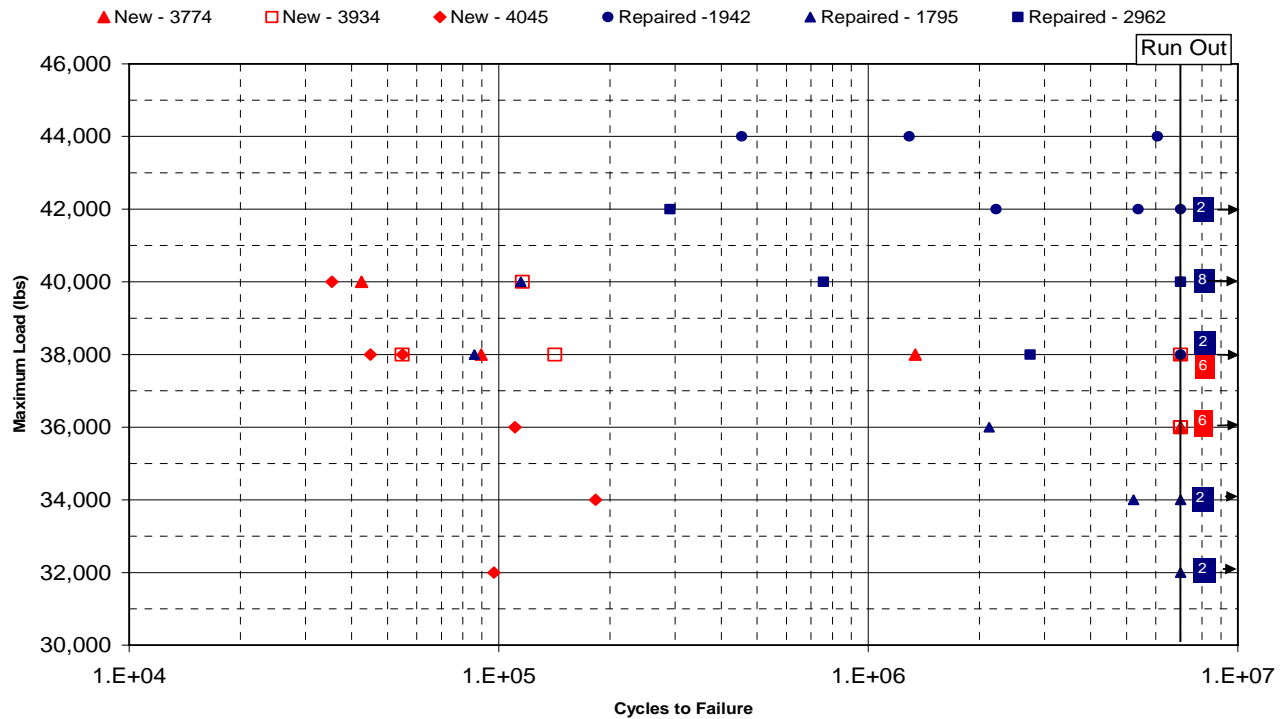
Figure 7. STF Data

Single Tooth Bending Fatigue Tests: Eighteen STF tests on baseline gears, yielding 24 data points and twenty (20) STF tests, yielding 28 data points, were conducted in this project. These are plotted in Figure 7. A test is considered a “run out” if no failure occurs after 7 million cycles. It is important to note that since two teeth are being tested at any given time, a run out yields 2 data points, while a failure yields only one data point.

From the data it can be concluded that the bending strength of the repaired gears meet or exceed the bending strength of new gears. A normal probability analysis of the data, which is summarized in Table 2, shows that the load required to obtain failure rates of 90%, 50% and 10% is greater for repaired gears than new gears.

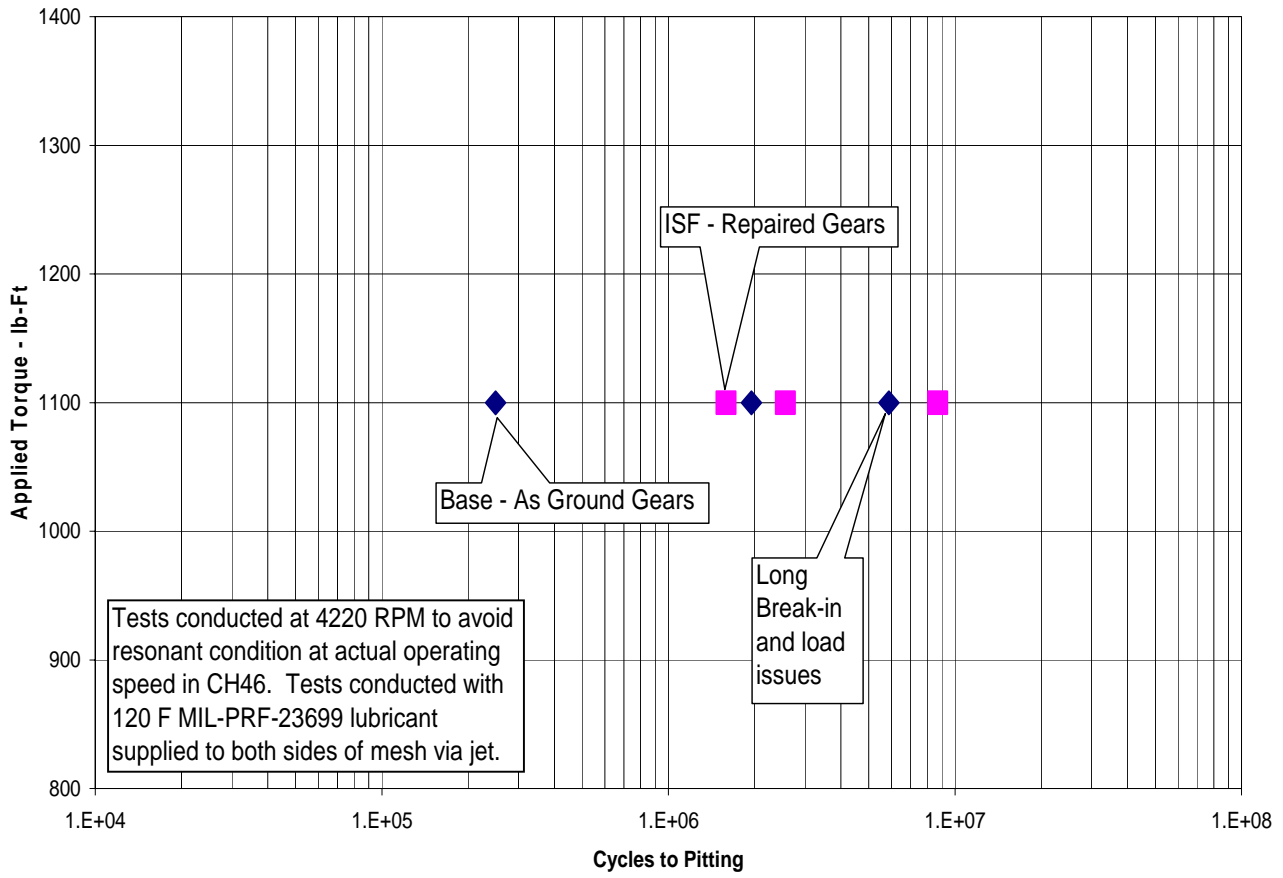
**Figure 8. Contact Fatigue Test Data**

Contact Fatigue Tests: The strategy pursued here was to identify the torque at which pitting failure occurs on the baseline spur pinions in a reasonable amount of cycles and establish the life of the repaired gears at the same load. The torque established on the new spur pinion was 1100 ft. lbs. to obtain pitting failure. After establishing that torque, two (2) further baseline tests and three (3) tests with repaired gears were conducted. The actual data points obtained in CF testing are plotted on Figure 8.

Table 3, obtained from the Weibull analysis, tabulates the G50 life, in cycles, for various confidence levels. The life for repaired gears is consistently above the life for new gears, indicating that the contact fatigue characteristics of scrap gears, repaired by super finishing, are as good if not better than new gears.

While damage on the scrap gears were in several different locations on the gear teeth, the repaired gears all failed at one edge of the face width due to the offset loading strategy adopted in the contact fatigue tests. This implies that prior damage on the scrap gears does not appear to have any impact on the failure of the repaired gears. This lack of correlation between damage on the scrap gears prior to repair and on the gears, after repair, was considered significant from NAVAIR’s perspective.

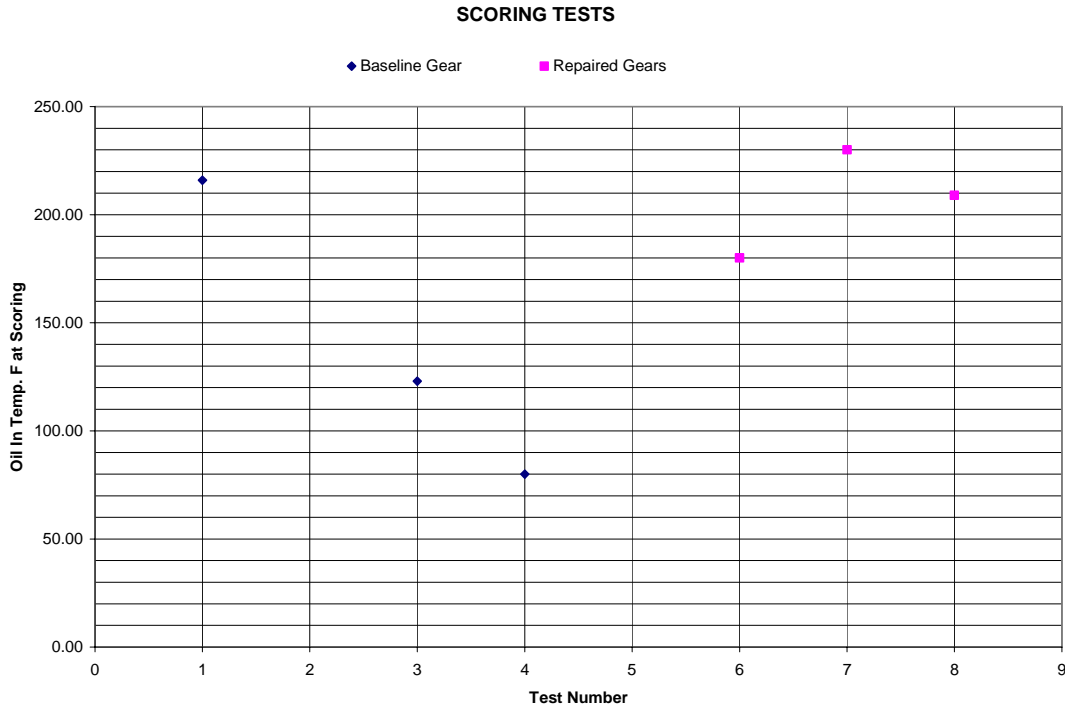
**Figure 9. Oil Inlet Temperature for Scoring Tests**

Scoring Resistance Tests: Since scoring resistance is a measure of the mating surface’s ability to operate in a condition where the lubricant film breaks down, the strategy in this test is to gradually increase the oil input temperature, with the gears operating at the torque used in the contact fatigue tests. The maximum oil input temperature at which scoring failure occurs is a direct measure of the tooth surface’s ability to resist scoring. The data obtained in this test is plotted in Figure 9.

The data in Figure 9 demonstrates that the repaired gears can be operated with a higher oil-in temperature than new gears, before scoring damage occurs. Consequently, it can be concluded that the repaired gears have a higher degree of scoring resistance. This can be directly attributed to the superior surface quality of the repaired gears over the new gears with a ground surface.
